# **Breast Implants: normal and abnormal findings. Basic aspects that the resident must know.**

Type: Educational Exhibit

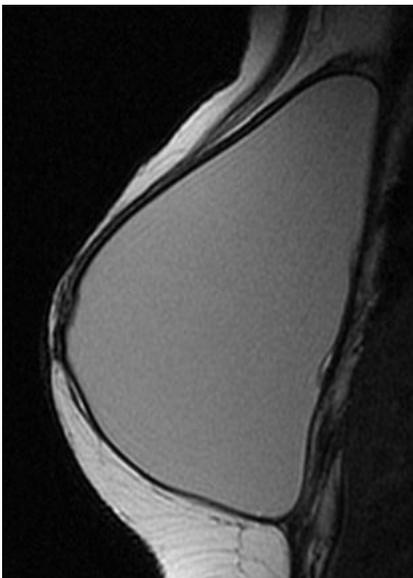
**Fig. 1:** Sagittal FSE T2-weighted sequence. Single lumen silicone filled in retropectoral location.

- Single lumen: filled with silicone (homogeneous high-signal-intensity viscous silicone on T2-weighted images) or saline solution (with different signal intensities depending on the pulse sequence). Fig. 1.
- Standard double lumen: filled with silicone gel in the inner lumen and with saline solution in the outer one (inner lumen of high signal-intensity silicone surrounded by a smaller outer lumen that contains saline and has different signal intensities).
- Reverse double lumen: saline solution in the inner lumen and silicone in the outer lumen. Fig. 2.
- Expanders.

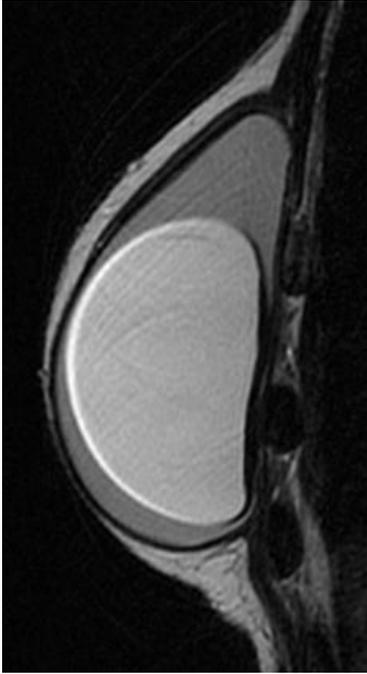
**Fig. 2:** Sagittal FSE T2-weighted image. Reverse double lumen implant.  
**References:** - Salamanca/ES

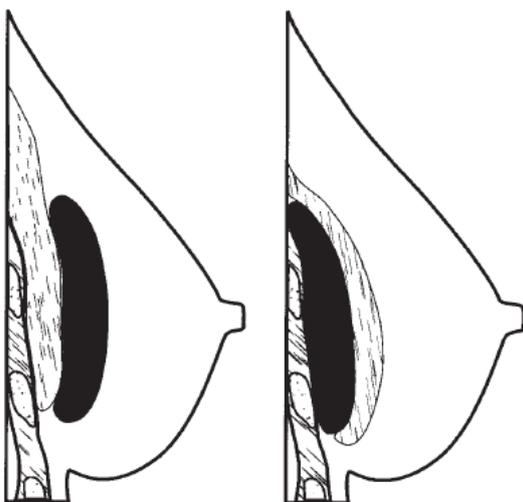
**Fig. 3:** Subglandular implant placement (left) and subpectoral implant placement (right).  
**References:** 2011, 2004 by Mosby, Inc., an affiliate of Elsevier Inc.

### **Location (Fig. 3)**

- Subglandular or retroglandular: located in front of the pectoralis major muscle. (Fig. 4).
- Subpectoral or retropectoral: behind the pectoralis major muscle, partial or completely. (Fig. 5).

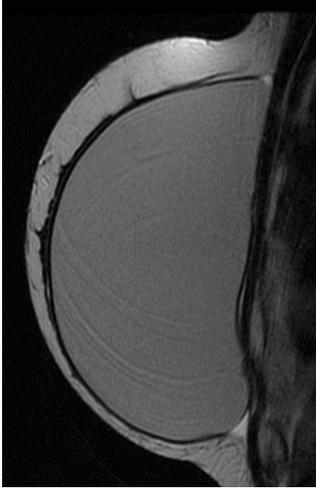
**Fig. 4:** Sagittal FSE T2-weighted image. Subglandular single lumen implant filled with silicone.

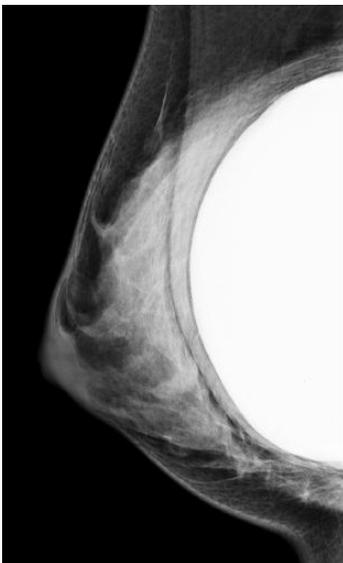
**Fig. 5:** Mediolateral oblique mammogram showing a retropectoral implant.

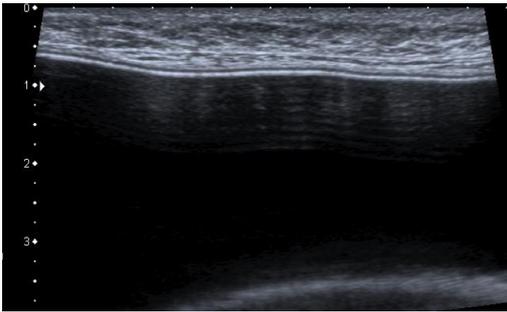
**Fig. 6:** Breast ultrasound showing a normal contour of the implant, a thin and continuous echogenic line at the parenchymal tissue-implant interface.

In a normal implant we can see regularity of the implant contour and homogeneous lumen with anechoic content in ultrasound (Fig. 6). We can

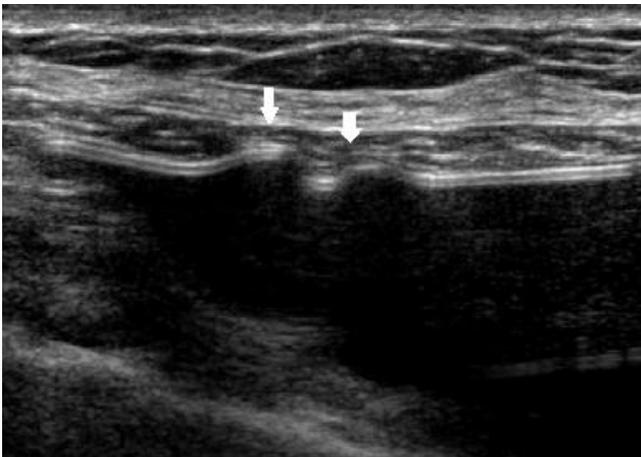
**Fig. 7:** Normal folds (arrows) in an intact implant.

observe radial folds (Fig. 7) that shouldn't be confused with a rupture. They represent infoldings of the shell into the silicone gel and extend perpendicularly from the periphery to the interior of the implant, without presence of silicone between its layers. Similar findings can be seen in expanders. The expander is placed in the mastectomy site prior to a permanent implant. It is placed in the collapsed form and will be slowly inflated afterwards, so it may have folds in the surface if it is not completely filled and it should not be interpreted as a rupture.

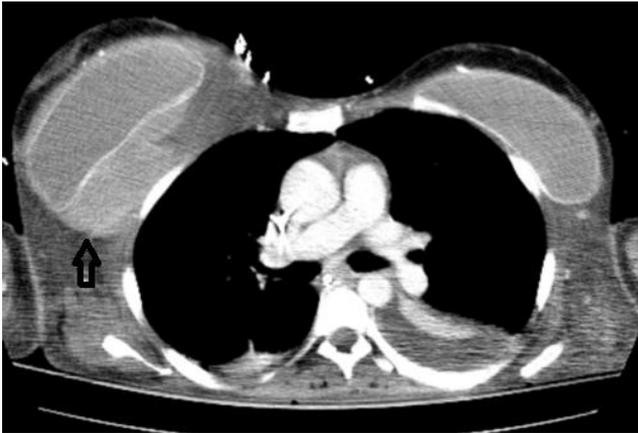
**Fig. 8:** Chest CT with i.v. contrast administration in a polytraumatized patient shows a hyperdense collection consistent with a hematoma posterior to the implant (arrow) with increased bulk of the right breast.

It usually appears in early stage after surgery or it could be posttraumatic (Fig. 8).

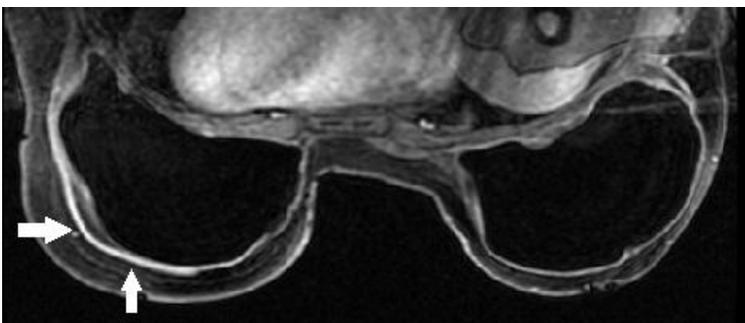
**Fig. 10:** Post-gadolinium fat-suppressed T1-weighted 3-D SPGR axial image, shows thickening and enhancement of the fibrous capsule consistent with capsulitis (arrows).

It is mainly a clinical diagnosis (Fig. 9) with a distorted, tough and sometimes painful breast. The radiological findings may include implant asymmetry, irregular contour, increased antero-posterior diameter, periimplant calcifications, peripheral (capsular) enhancement after endovenous contrast administration (Fig. 10 and Fig. 11) and capsular adhesion to the pectoralis muscle in a more severe form of capsulitis.

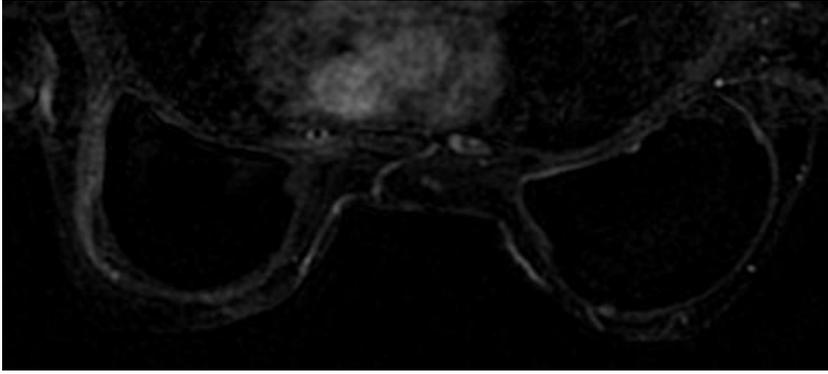
**Fig. 11:** T1-weighted 3-D SPGR before and dynamically following gadolinium and post-gadolinium fat-suppressed T1-weighted 3-D SPGR subtraction image shows fibrous capsule enhancement.

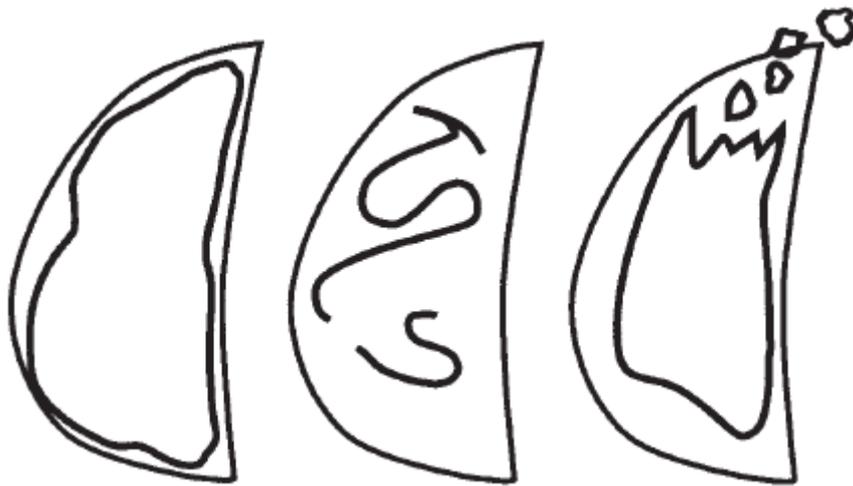
**Fig. 12:** Schematic of implant complications. Left: fibrous capsule normally surrounds the intact implant. Middle: Intracapsular rupture. The implant shell is ruptured, but the silicone is contained in the fibrous capsule. Right: Extracapsular rupture. The implant capsule and the fibrous capsule are damaged, and silicone is outside the fibrous capsule.

The rupture is classified in two categories depending on the location of the silicone with respect to the fibrous capsule (Fig. 12)

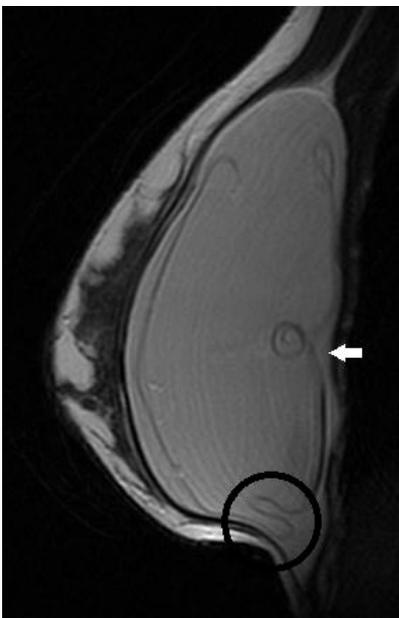
**Fig. 13:** Sagittal FSE T2-weighted image. Intracapsular rupture of a single lumen silicone-filled implant with intracapsular rupture. "Linguine" sign (arrow) and "keyhole" sign (circle).

The most reliable criterion is the linguine sign, (Fig. 13) that reflects collapsed intracapsular rupture. It is due to the presence of layers of collapsed shell that appear as multiple curvilinear low-signal intensity lines floating in the high-signal intensity silicone gel.

"Keyhole", "noose" or "inverted-loop" sign (Fig. 13): is a progression of the "pull-away" sign in which the separated layer of the inner membrane, creating a radial fold that looks like a keyhole. It signifies an incipient rupture and is the most common form of intracapsular rupture.

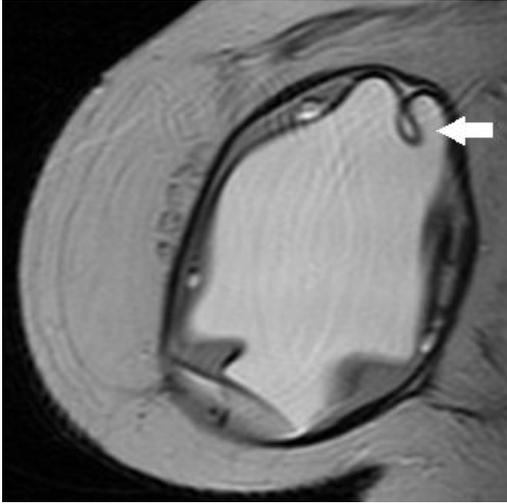
**Fig. 14:** Sagittal FSE T2-weighted sequence. Intracapsular rupture in a reverse double-lumen implant. "Teardrop" sign (arrow).

"Teardrop" sign (Fig. 14): it differs from the keyhole sign in that margins of the collapsing shell contact one another.

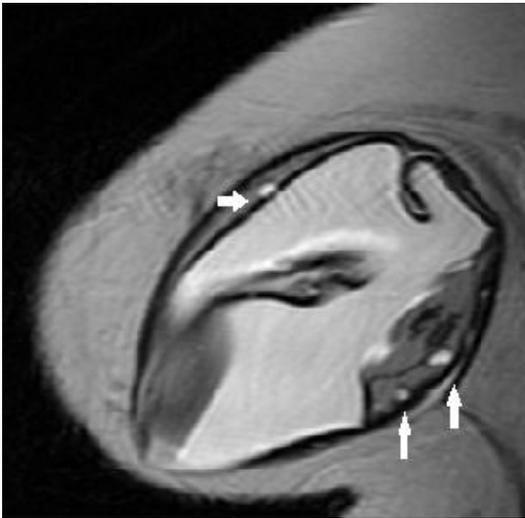
**Fig. 15:** Sagittal FSE T2-weighted sequence. Intracapsular rupture in a reverse double-lumen implant. "Salad-oil" sign (arrow).

Whether if it is a collapsed or uncollapsed rupture we can find small hyperintense saline drops within the implant, termed the "salad-oil" or "droplet" sign (Fig. 15) It is nonspecific and not reliable without other evidence of implant rupture, but should prompt the search for subtle signs of rupture.

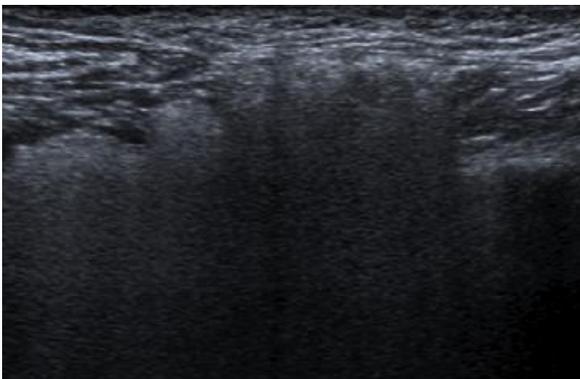
**Fig. 16:** Extracapsular implant rupture. Breast ultrasound showing an echogenic mass with dirty posterior shadowing, termed the "snowstorm" sign.

**Ultrasound:** the most reliable US sign is the presence of silicone in the parenchyma or the lymph nodes. When it is a conglomerate (Fig. 18) it appears as a hypoechoic or anechoic mass and can form siliconomas or silicone granulomas due to a foreign-body reaction, in which fibrous tissue reaction surrounds the silicone. More frequently we can see the "snowstorm" sign (Fig. 16), an echogenic nodule with dirty posterior shadowing.

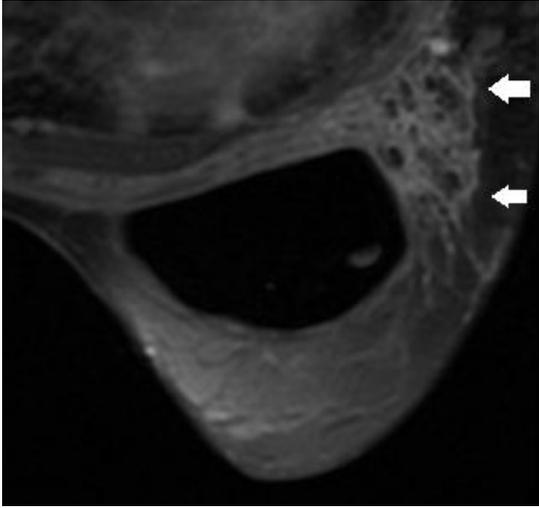
**Fig. 17:** Extracapsular implant rupture. Axial T1-weighted gadolinium- enhanced image shows extracapsular silicone in the lateral aspect of the right breast parenchyma, adjacent to the implant with peripheral inflammatory reaction and tissue enhancement (arrows).

In the short-term, the silicone signal in the breast will be as bright as the silicone within the implant (Fig. 17, Fig. 18, Fig. 19 and Fig. 20). With granulomatous formation, the signal of the extracapsular silicone will decrease to a variable extent.

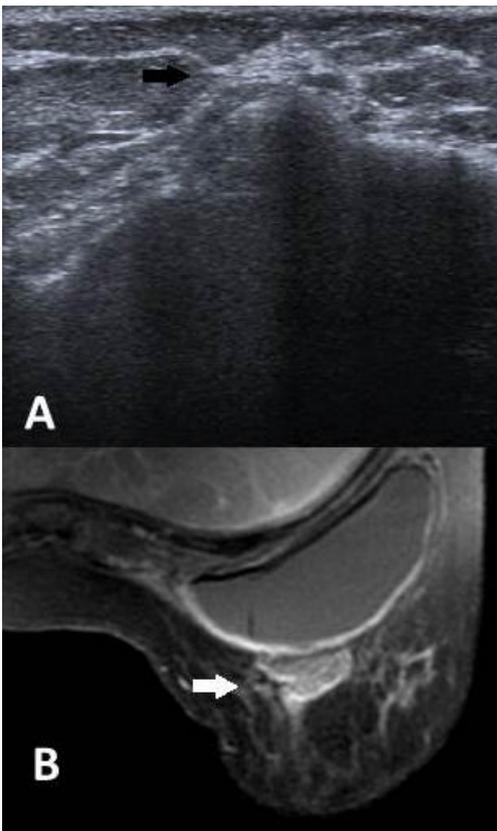
**Fig. 18:** A)Ultrasound image shows a hypoechoic mass next to the anteroinferior and medial aspect of the implant (black arrow). B)Post-gadolinium fat-suppressed T1-weighted 3-D SPGR, axial image shows corresponding extracapsular mass consistent with extracapsular silicone rupture of right breast implant (white arrow).

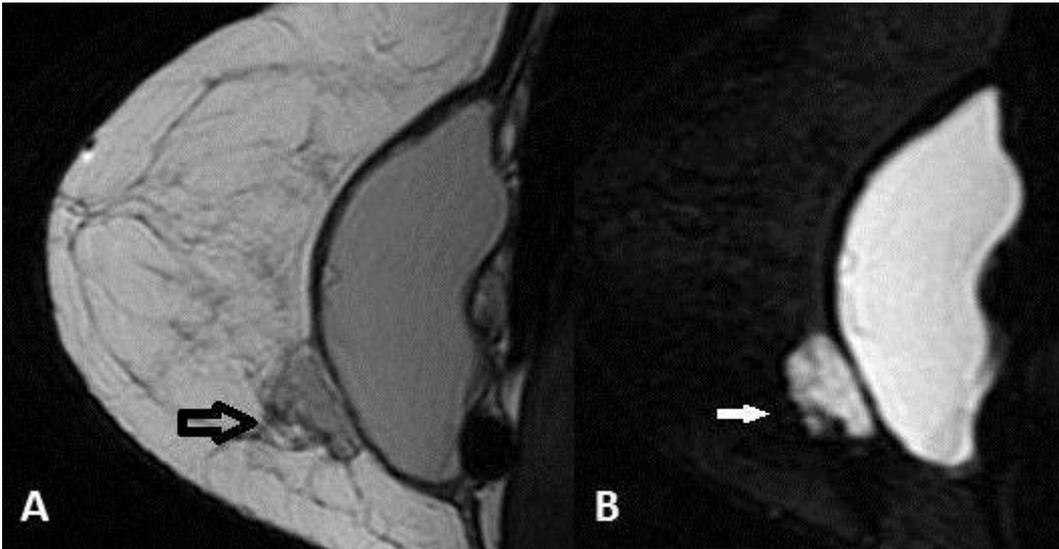
**Fig. 19:** Sagittal FSE T2 weighted image (A) and silicone-excited sequence (B) show isointense extracapsular silicone (arrow) anteroinferior to the right breast implant, consistent with extracapsular silicone rupture.

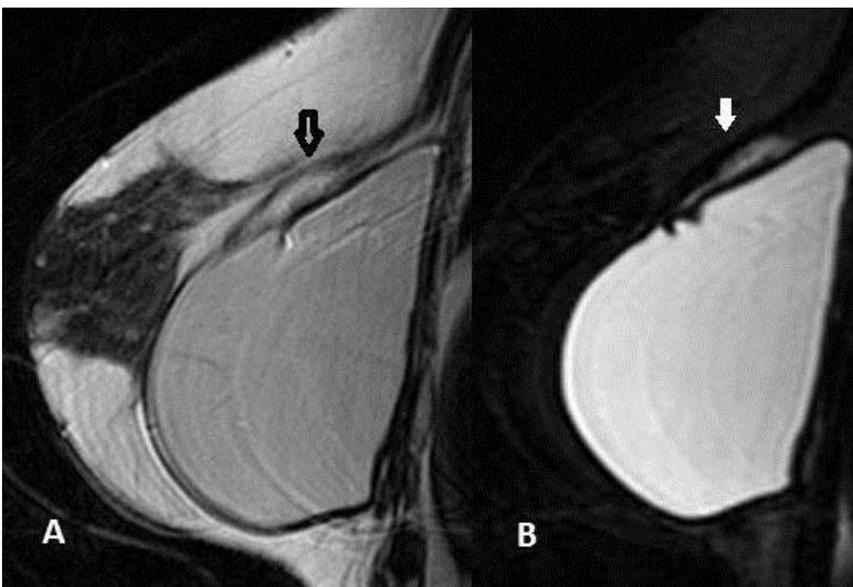
**Fig. 20:** Extracapsular rupture. A) Sagittal T2 FSE image and silicone-selective image (B) show isointense extracapsular silicone (arrow) anterosuperior to the breast implant.

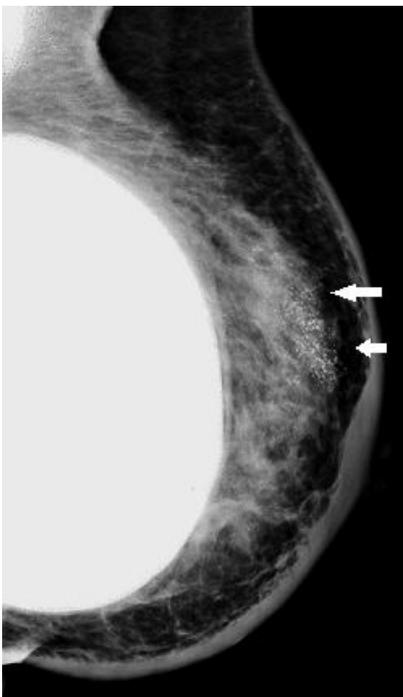
**Fig. 21:** Left Mediolateral oblique mammogram. A cluster of suspicious microcalcifications are identified in the breast gland (arrows) with associated skin thickening. Imaging guided biopsy confirmed the diagnosis of infiltrating ductal carcinoma.

In this patients, any abnormality should be assessed with US and/or MRI with contrast, and if necessary, a fine-needle aspiration or core needle biopsy should be performed. (Fig. 21, Fig. 22, Fig. 23 and Fig. 24).

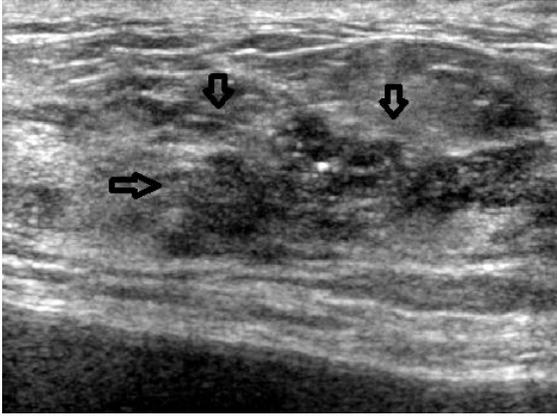
**Fig. 22:** Breast ultrasound image showing an irregular lobulated hypoechoic mass. Imaging guided biopsy confirmed the diagnosis of infiltrating ductal carcinoma.  
**References:** - Salamanca/ES

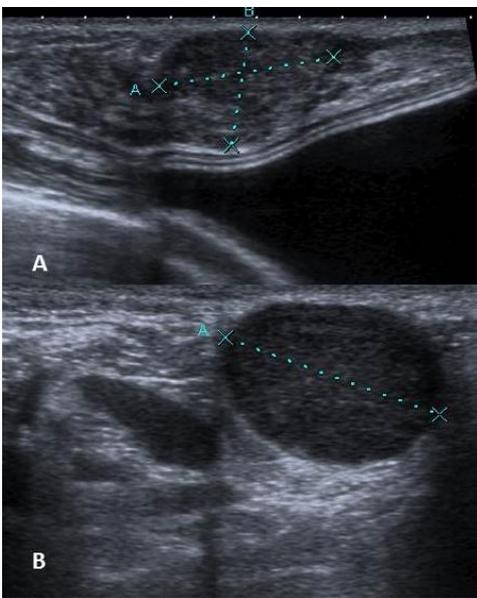
**Fig. 23:** A) Ultrasound image of a hypoechoic mass with lobulated margins in the upper left breast, biopsy-proven invasive lobular carcinoma. B) Left axillar region with rounded, enlarged and hypoechoic lymph nodes consistent with metastasis.  
**References:** - Salamanca/ES

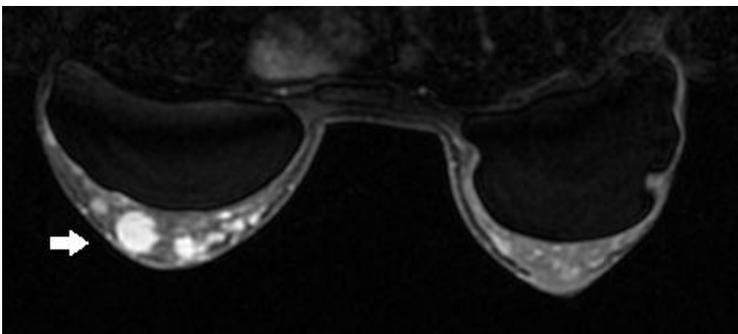
**Fig. 24:** Post-gadolinium fat-suppressed T1-weighted 3-D SPGR shows multiple enhanced nodules biopsy-proven invasive lobular carcinoma (arrow).  
**References:** - Salamanca/ES

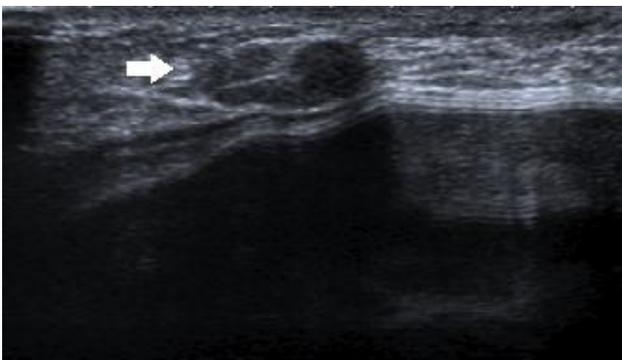
**Fig. 25:** Breast ultrasound. Biopsy-proven fibroadenoma at the 10 o'clock position of the left breast.

On ultrasound (Fig. 25) fibroadenomas are oval, well-circumscribed homogeneous masses, usually wider than tall. They are hypoechoic but may occasionally contain cystic spaces.
